# Manhole Inspection Summary

Manhole # S51M\_\_012MH

Insp Date: **12/22/08 2:05 PM**

**Location** Address: **rear 823 s lakewood av**

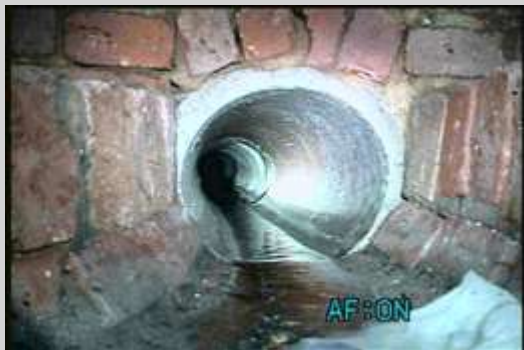
12 O'Clock Outflow

8 in. Circular Gravity Sewer  
Pipe Out @ 12 O'Clock

Pipe Material: **Clay** ☐ Pipe Lined

Invert Depth: **7.75** (ft.) Flow Characteristics: **Fast**

Deposits: ☒ None ☐ Mud ☐ Sludge ☐ Debris ☐ Grease

Infiltration: **None** Pipe Seal Cond: **Unknown**

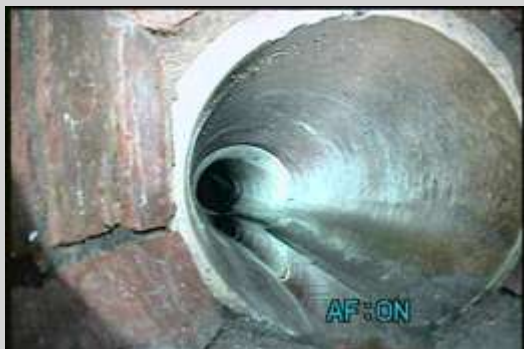
7 O'Clock Inflow

8 in. Circular Gravity Sewer  
Pipe In @ 7 O'Clock

Pipe Material: **Clay** ☐ Pipe Lined

Invert Depth: **7.66** (ft.) Flow Characteristics: **Slow**

Deposits: ☒ None ☐ Mud ☐ Sludge ☐ Debris ☐ Grease

Infiltration: **None** Pipe Seal Cond: **Unknown**

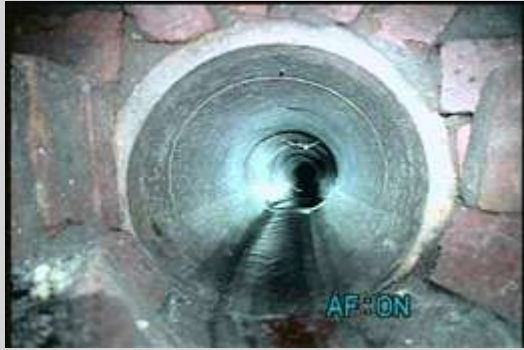
9 O'Clock Inflow

8 in. Circular Gravity Sewer

Pipe In @ 9 O'Clock

Pipe Material: **Clay** ☐ Pipe Lined

Infiltration: **None** Pipe Seal Cond: **Unknown**
